Manhole Inspection Summary

Manhole # S49CC_003MH

Inspection ☐ Is Incomplete Rating: **3) Fair**

Insp Date: **6/16/08 9:17 AM**

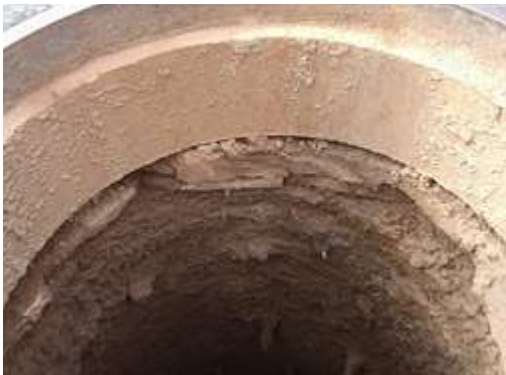
Defect 1

Condition: ☐ Sound ☐ Cracked ☐ Root Intrusion ☒ **Loose Brick** ☐ Deteriorated

loose bricks

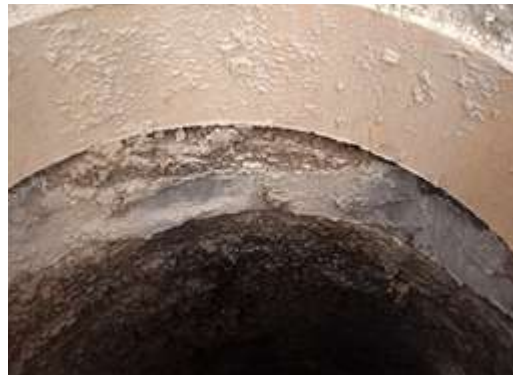
Defect 2

Infiltration: ☐ None ☐ Joint ☐ Cracks ☒ **Mortar** ☐ Roots ☐ Wall

Infiltration: ☐ None ☐ Joint ☐ Cracks ☐ Mortar ☐ Roots ☒ **Wall**

infiltration

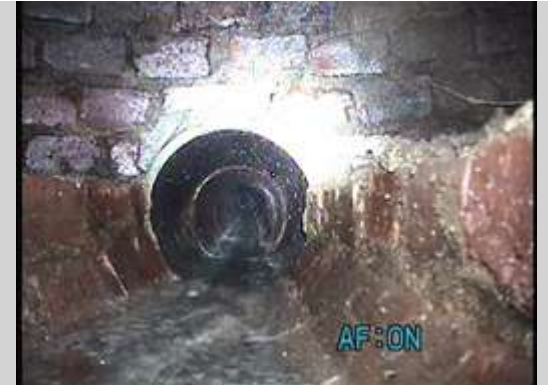
12 O'Clock Outflow

8 in. Circular Gravity Sewer
Pipe Out @ 12 O'Clock

Pipe Height: **8.4** (in.) Rod and Bar (Angled)
Pipe Material: **Clay** ☐ Pipe Lined
Invert Depth: **11.10** (ft.) Flow Characteristics: **Fast**
Deposits: ☒ None ☐ Mud ☐ Sludge ☐ Debris ☐ Grease
Silt Depth: (in.) Deposits Extent:
Infiltration: **None** Pipe Seal Cond: **Sound**

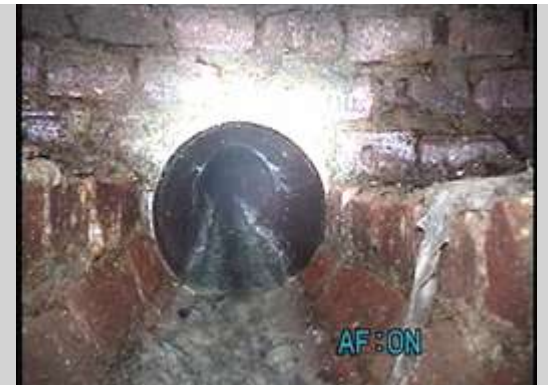
6 O'Clock Inflow

8 in. Circular Gravity Sewer
Pipe In @ 6 O'Clock

Pipe Height: **8.4** (in.) Rod and Bar (Angled)
Pipe Material: **Clay** ☐ Pipe Lined
Invert Depth: **11.05** (ft.) Flow Characteristics: **Fast**
Deposits: ☒ None ☐ Mud ☐ Sludge ☐ Debris ☐ Grease
Silt Depth: (in.) Deposits Extent:
Infiltration: **None** Pipe Seal Cond: **Sound**

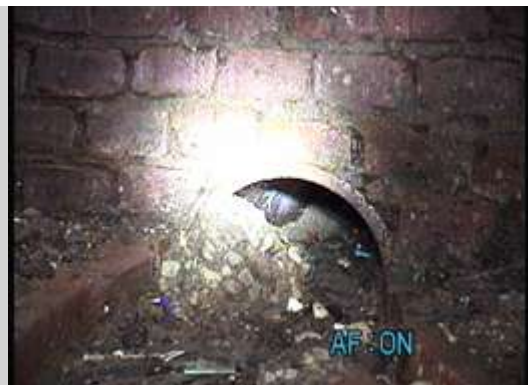
9 O'Clock Inflow

Pipe In @ 9 O'Clock

Connects To: **Stub connection / abandoned**
